Influence of Ingested Nuclear Cloud Dust and Overpressure Waves on Gas Turbine Engine Behavior (U)

Michael G. Dunn
Calspan Corporation
P.O. Box 400
Buffalo, NY 14225

November 1993

Technical Report

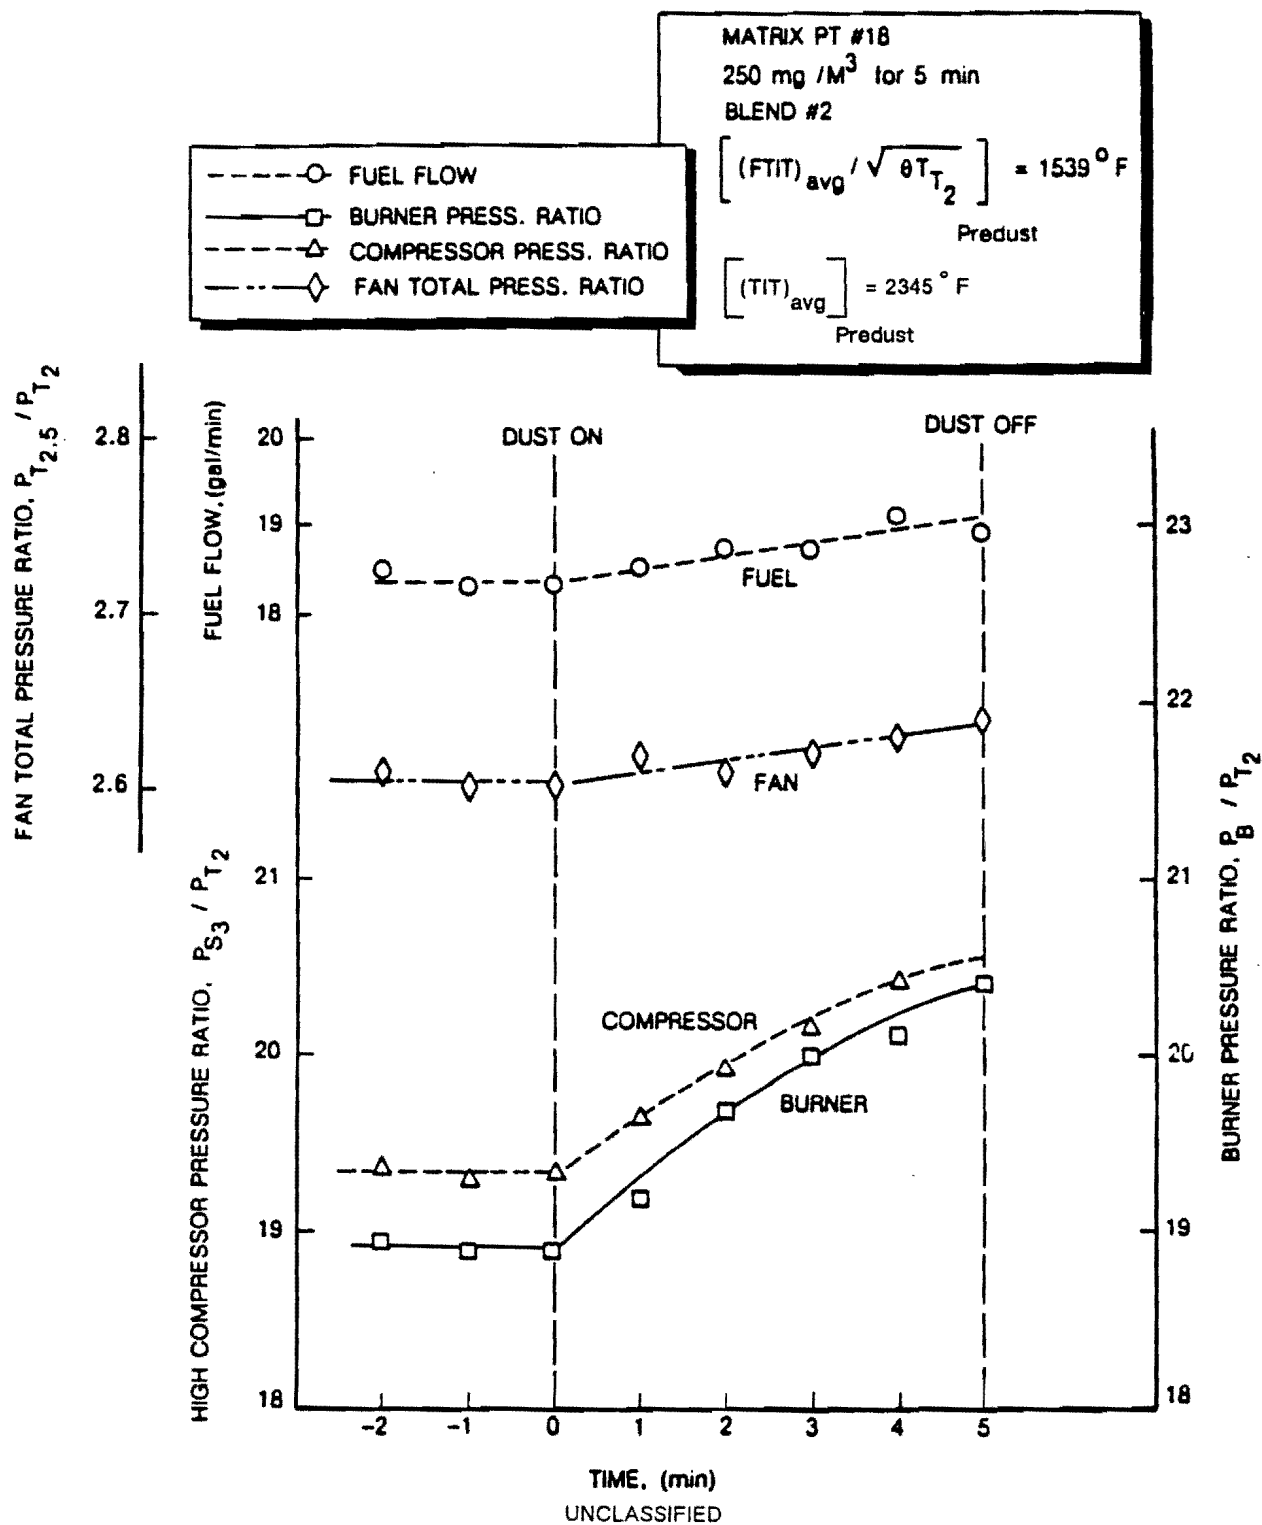
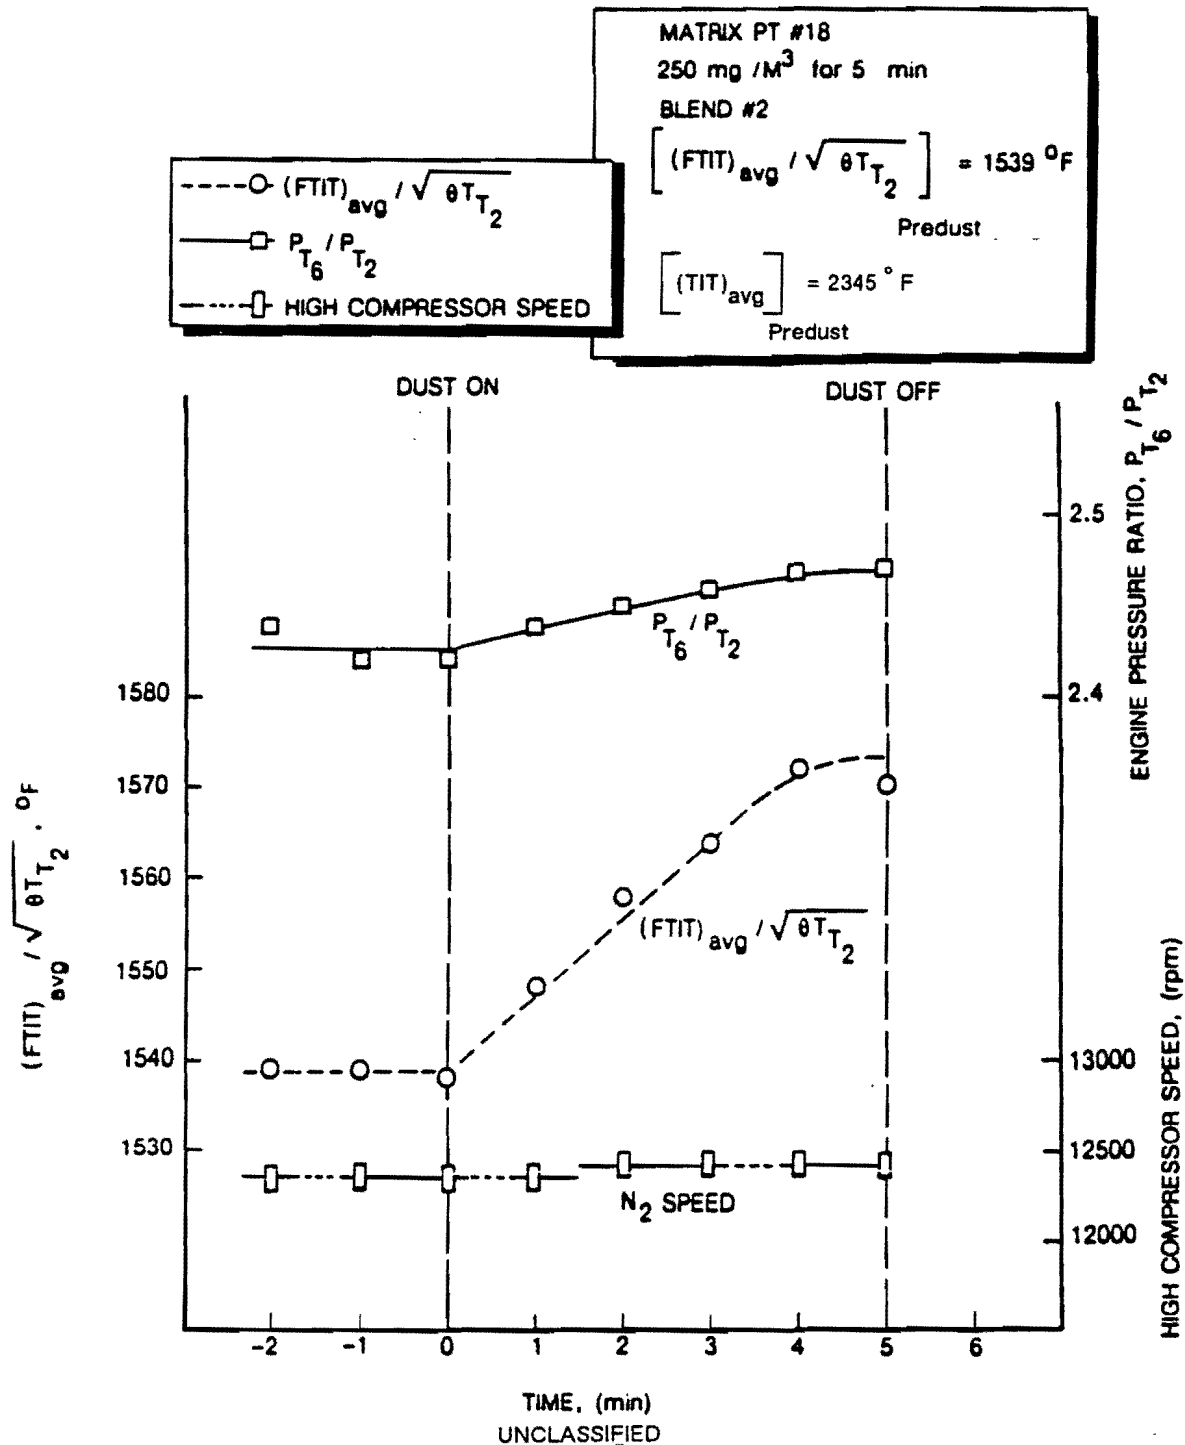
Figure 4.7. (U) Time history of F-100-PW-100 engine parameters during dust exposure.

(U) Figure 4.7 also includes the fuel flow rate and the fan total pressure ratio, both of which reflect the presence of the dust cloud, but not as dramatically. The rate of rise of the pressure is a strong function of the turbine inlet temperature, the chemical properties of the dust material, and the dust cloud concentration. A continuation of Figure 4.7 presents the corrected fan total inlet temperature (FTIT), the engine pressure ratio (EPR), and the core speed (N_2). The FTIT and EPR are both parameters available to the air crew on the instrument panel. Note that the FTIT is a very good indication of impending problems. The change in EPR would be much more difficult to observe especially during times of heavy work load. Changes in the core speed (N_2) and the fan speed (N_1) are indirect indicators of the deposition or erosion as seen through the response of the control system. However, these changes are so small that they would not be observed by the air crew.

(u) As was noted above, the buildup of material on the first vane causes the very rapid increase in burner static pressure and in compressor discharge static pressure shown in Figures 4.7. At high altitude, this pressure increase can lead to surge and engine flame-out. If the engine surges at high altitude, then flame-out is more likely than at low altitude. The air crew must be aware that a high-altitude engine restart is significantly different from a low-altitude restart. Boeing Commercial Airplane Company has recently changed their procedure instructions to airmen regarding this event and it is anticipated that other companies will soon follow suit. In addition, Boeing has made a videotape for air crews that treats this problem in some detail.

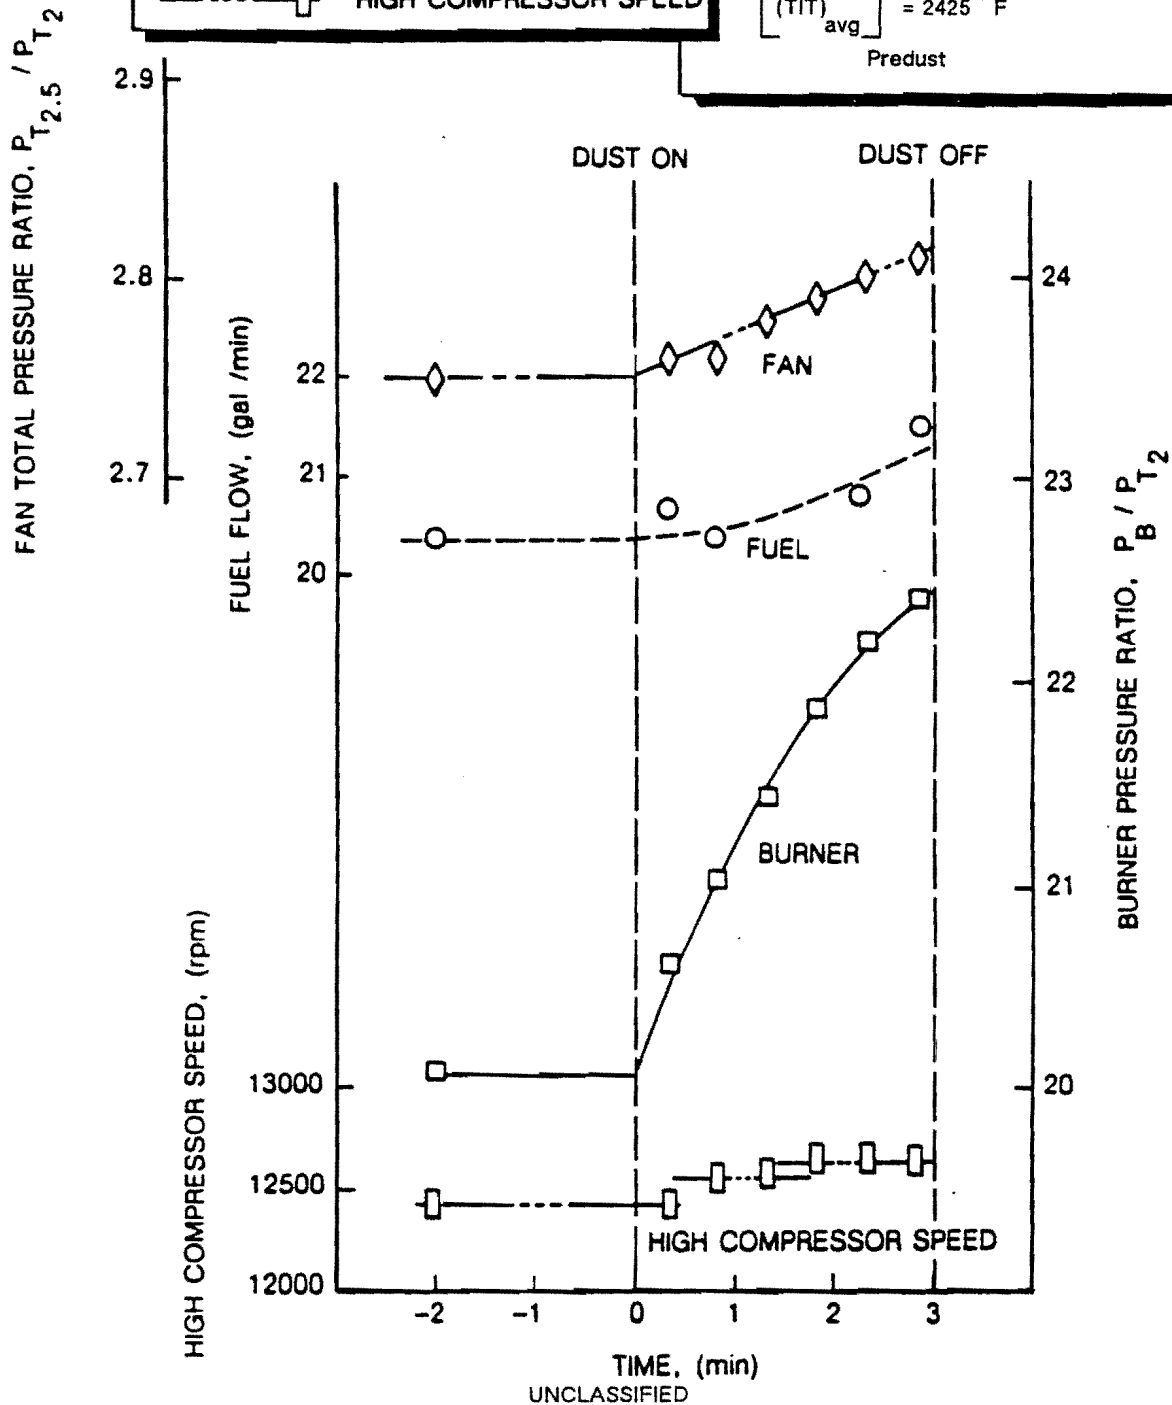
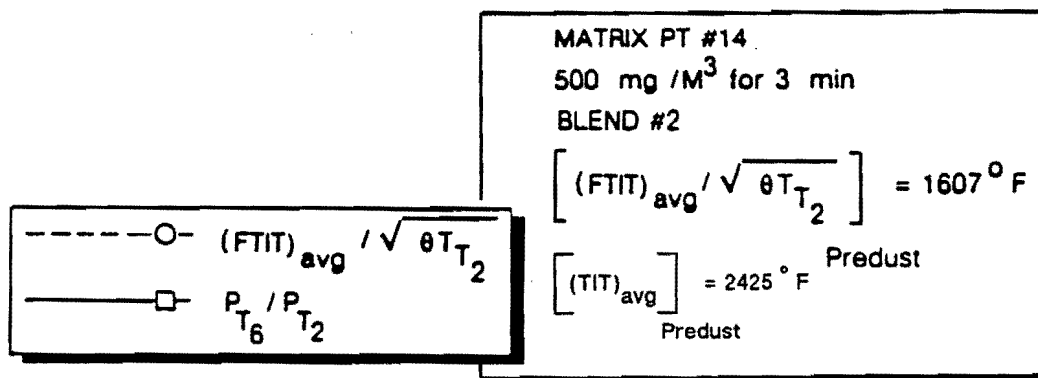
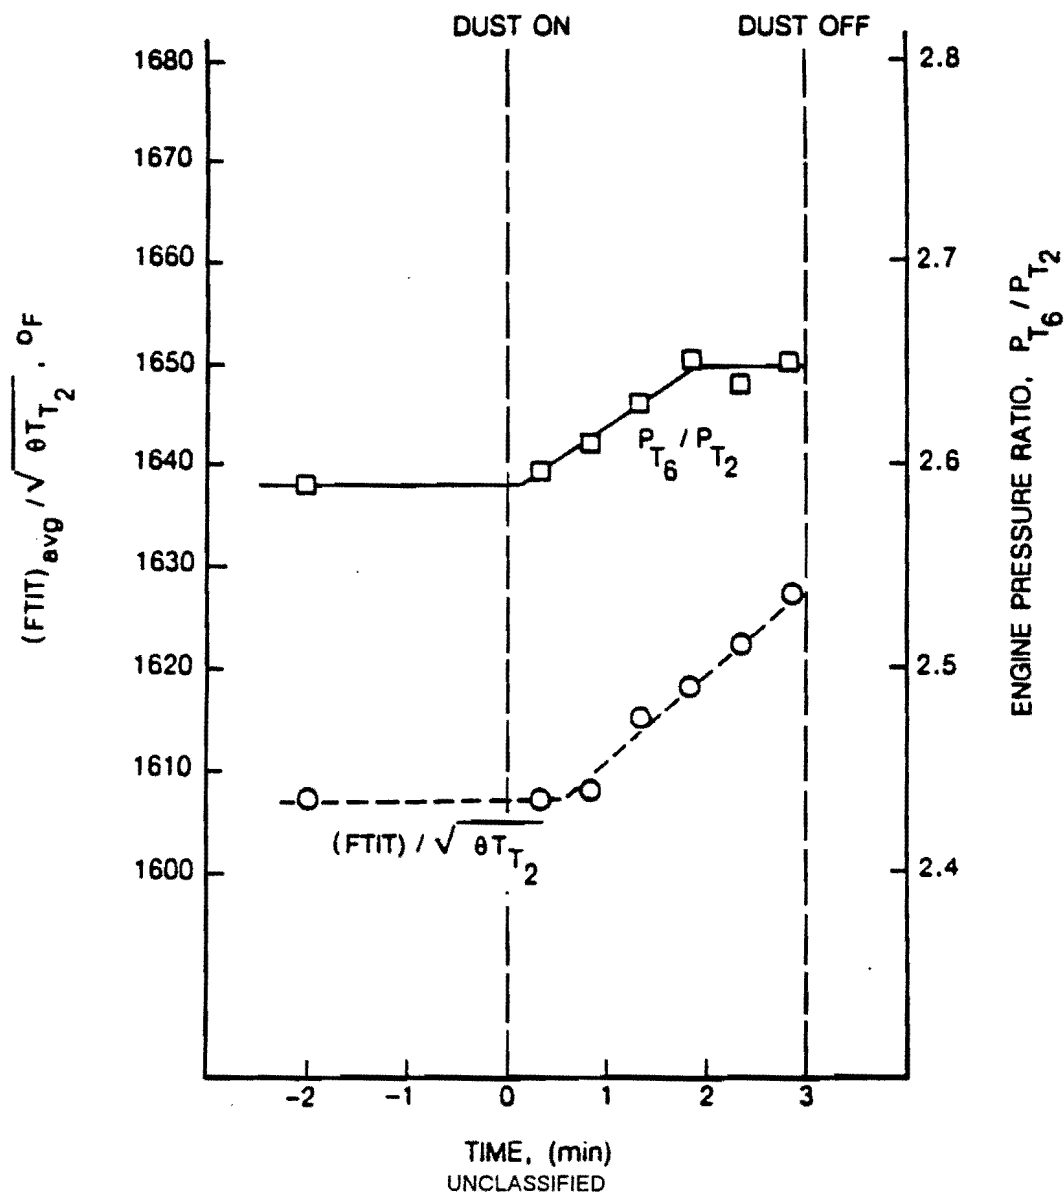
Figure 4.8. (U) Time history of F-100-PW-100 engine parameters during dust exposure.

(U) On several occasions, the importance of dust concentration and exposure time has been mentioned. Figures 4.8 present parameters similar to those presented in Figures 4.7 for a similar engine operating point. The primary difference between these results is that the dust concentration has been increased by a factor of two. The burner pressure shown on Figure 4.8 increases much more rapidly than it did at the lower concentration, increasing from about 20 atm. to 22.5 atm. in three minutes. The second of Figure 4.8 shows correspondingly large increases in both EPR and FTIT.

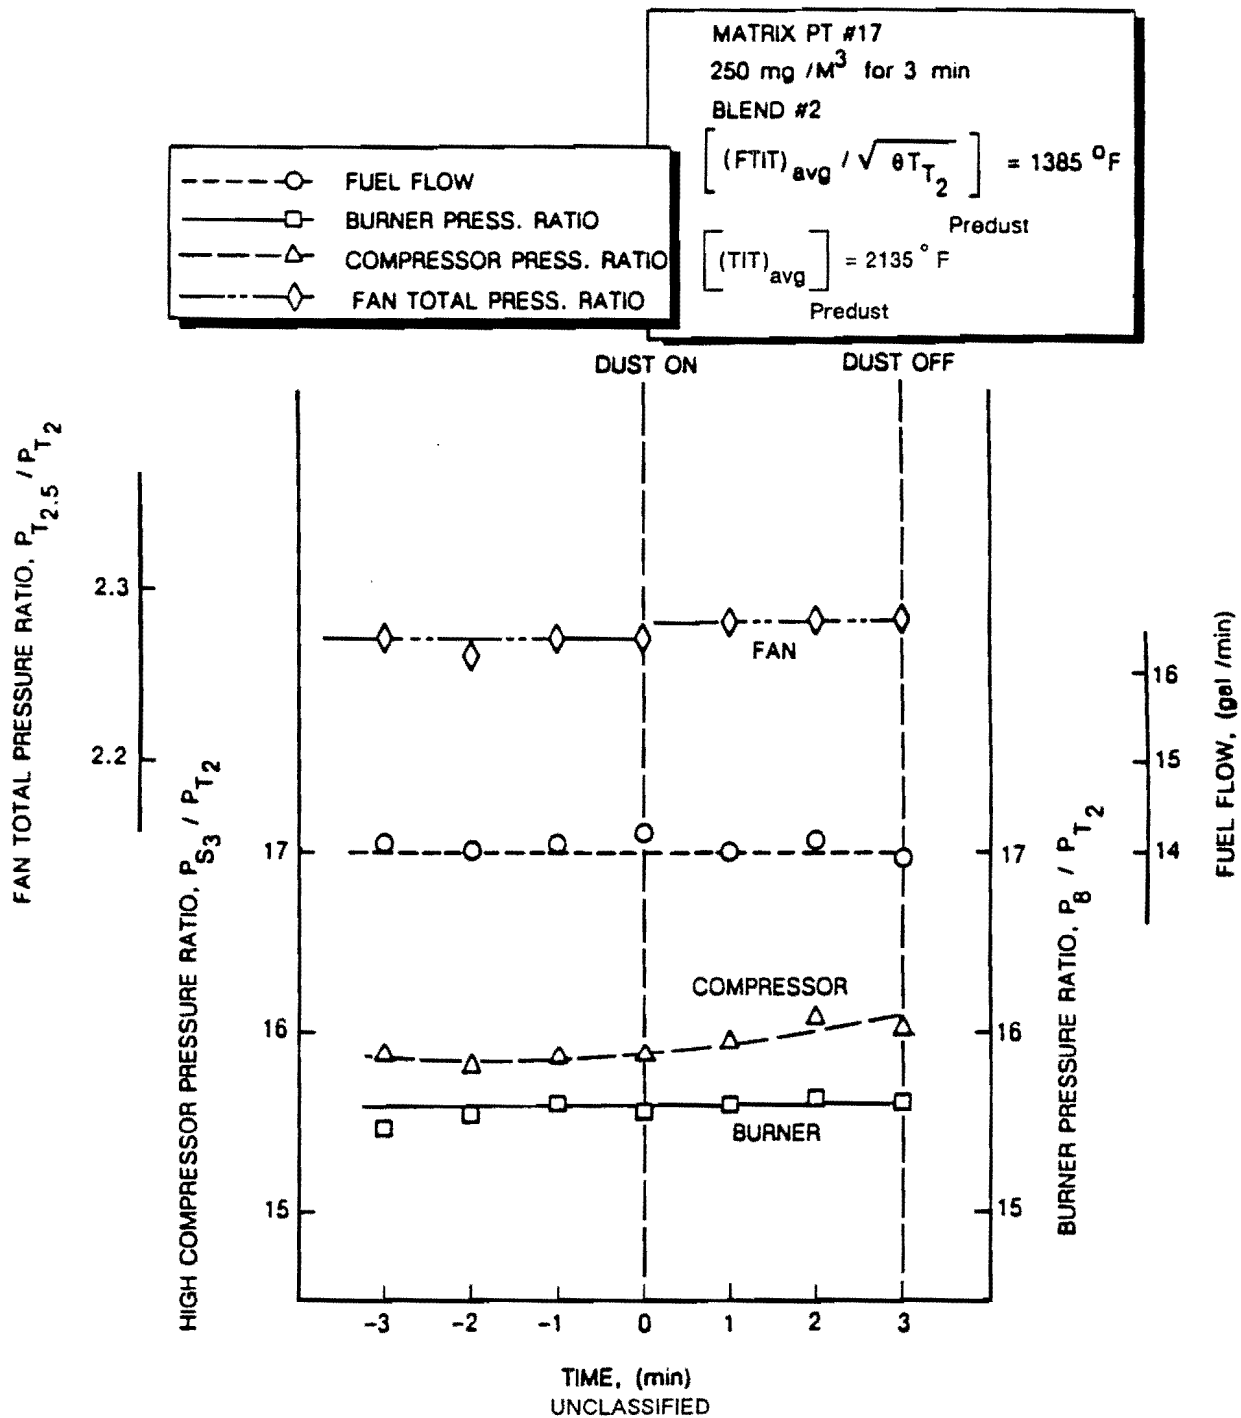
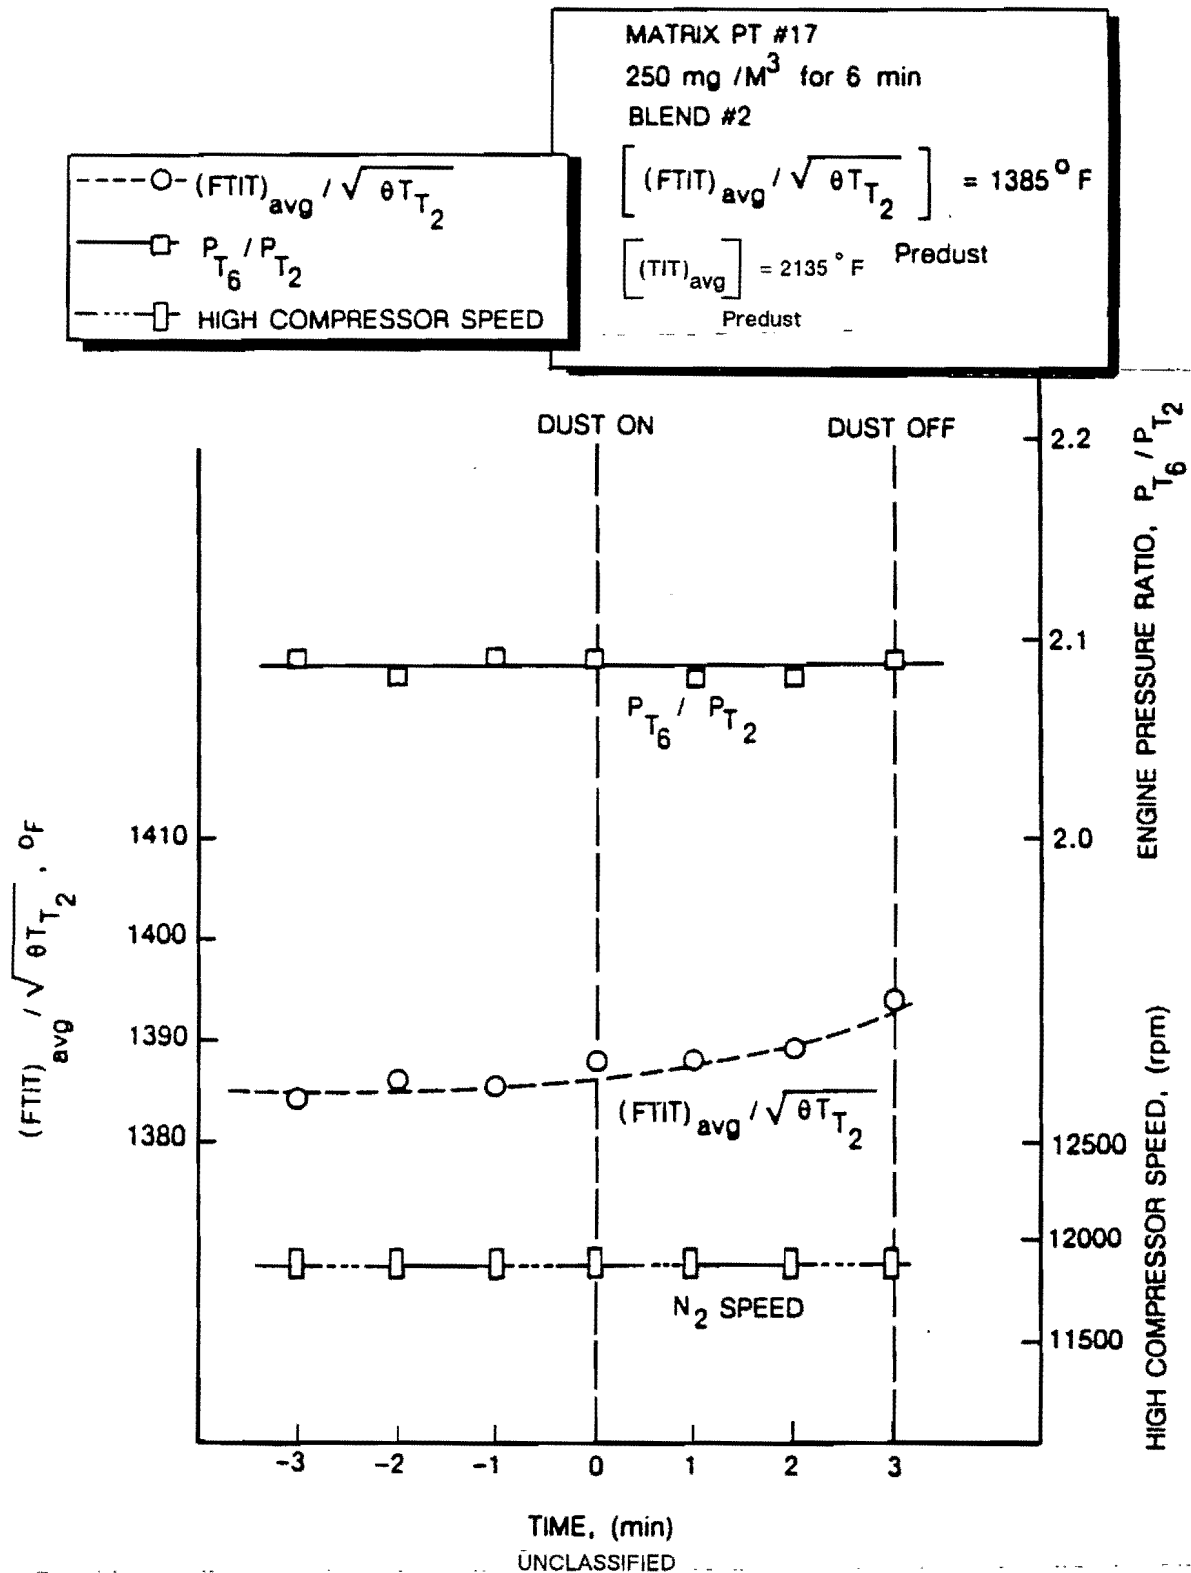
Figure 4.9. (U) Time history of F-100-PW-100 engine parameters during dust exposure.

[REDACTED] An investigation of the threshold in turbine inlet temperature necessary to avoid melting of the ingested material and/or deposition on the turbine stage was part of the study described above. Figures 4.9 present a portion of the results of that investigation. For a TIT of 2135°F, there is a relatively small increase in compressor discharge pressure and in FTIT which occurs near the end of the dust exposure time. Subsequent measurements demonstrated that for the particular dust blend being used (blend #2), deposition did not occur if the TIT was maintained at 2000°F or less.

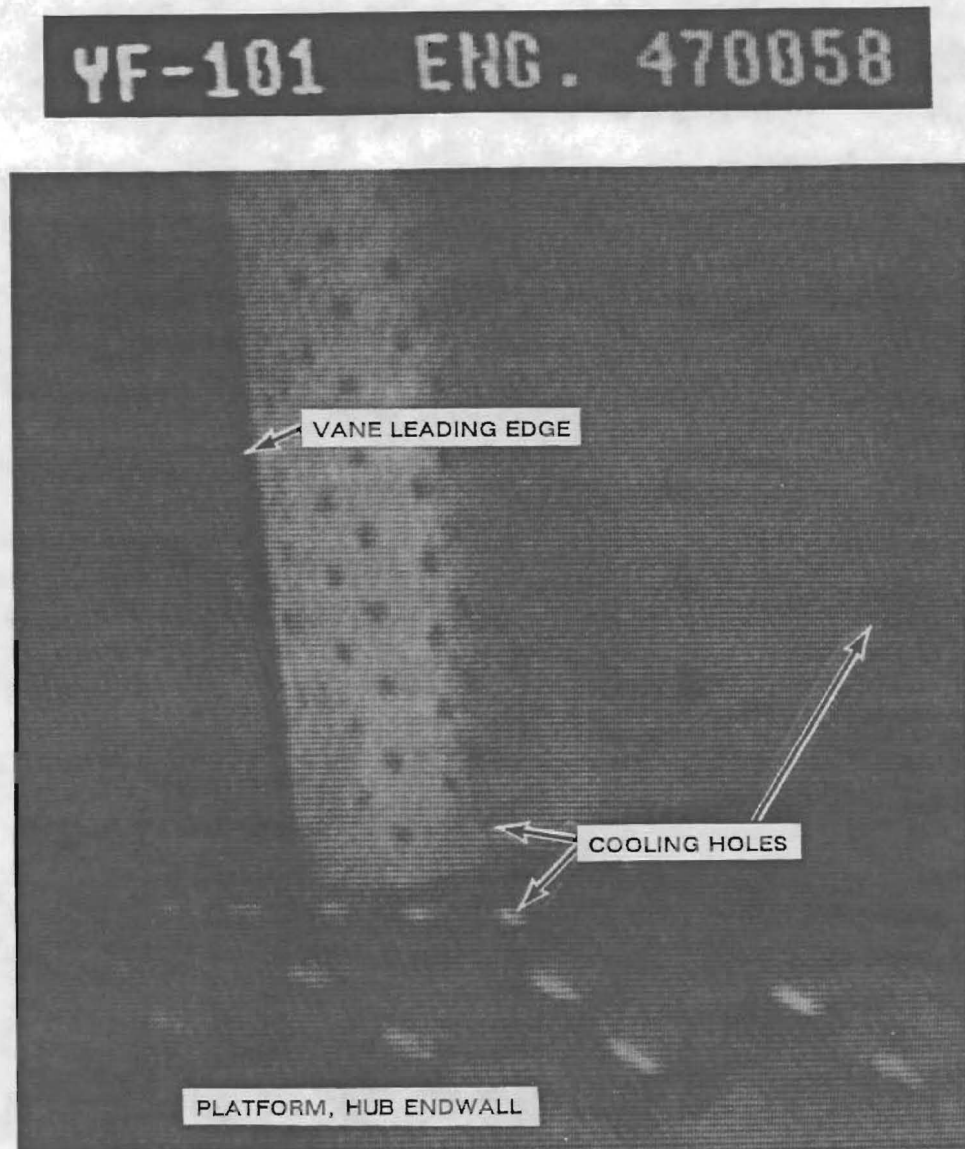
u [REDACTED] Figure 4.14 is a pre-test photograph of the entrance to the high pressure turbine first vane which illustrates that the turbine was in excellent shape prior to initiation of the dust ingestion program. The second figure of Figure 4.14 is a post-test photograph of a portion of the first vane row of the high pressure turbine which illustrates severe deposition on the vane leading edge, pressure surface, and a portion of the suction surface. As shown, the build-up of material is present not only on the vane leading edge and pressure surface but also on the hub endwall. Also note that the deposits are very heavy near the tip endwall, even more so than observed for the F100 engine. Figure 4.15 is a close-up post-test photograph of one of the first vane leading edges that was typical of most vanes; it illustrates that the cooling holes were completely blocked and no cooling air was exiting the vane. It was noted earlier that the YF engines had a dust filter at the entrance to the vane cooling passages that the production engines do not have. Figure 4.16 is a post-test photograph of this filter illustrating that it is heavily contaminated with dust material. It is probable that this filter is severely blocked so that very little air was actually getting into the vane cooling passages. This reduced air flow resulted in increased vane metal surface temperature which then caused the very heavy deposits observed. This effect also reduced our ability to clear the turbine of deposits for any significant length of time by cycling the engine.

Figure 4.14. (U) Pre-test photograph of inlet to first vane of YF-101-GE-100 high pressure turbine.
